**PRELIMINARY ASSESSMENT/
VISUAL SITE INSPECTION**

**FANSTEEL ESCAST
ADDISON, ILLINOIS
ILD 000 672 139**

FINAL REPORT

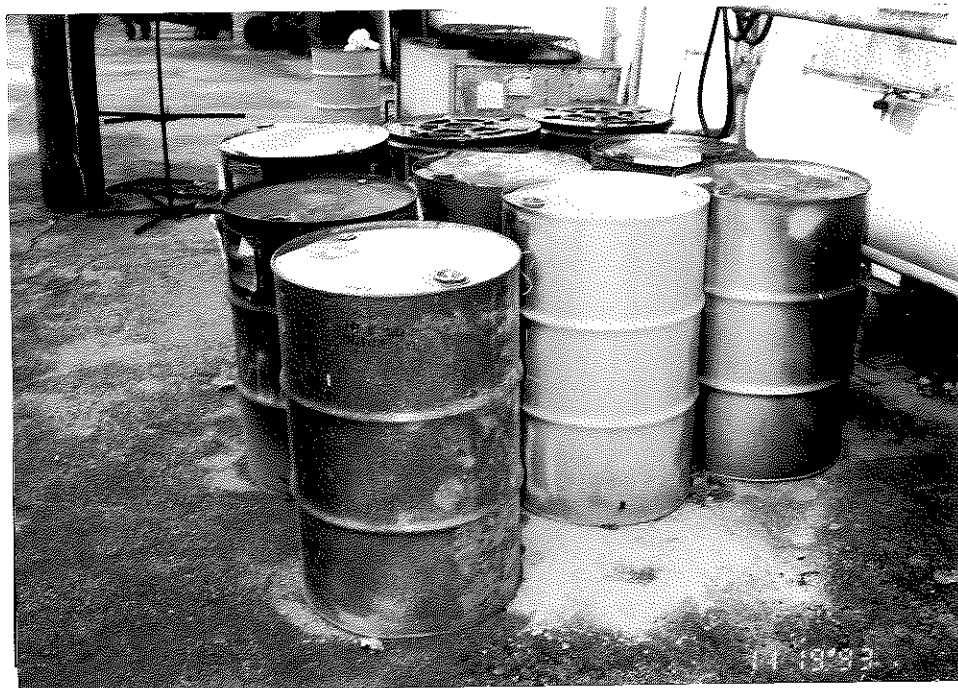
Photograph No. 3
 Orientation: South
 Description: Drums of waste oil

Location: SWMU 1
 Date: 11/19/93

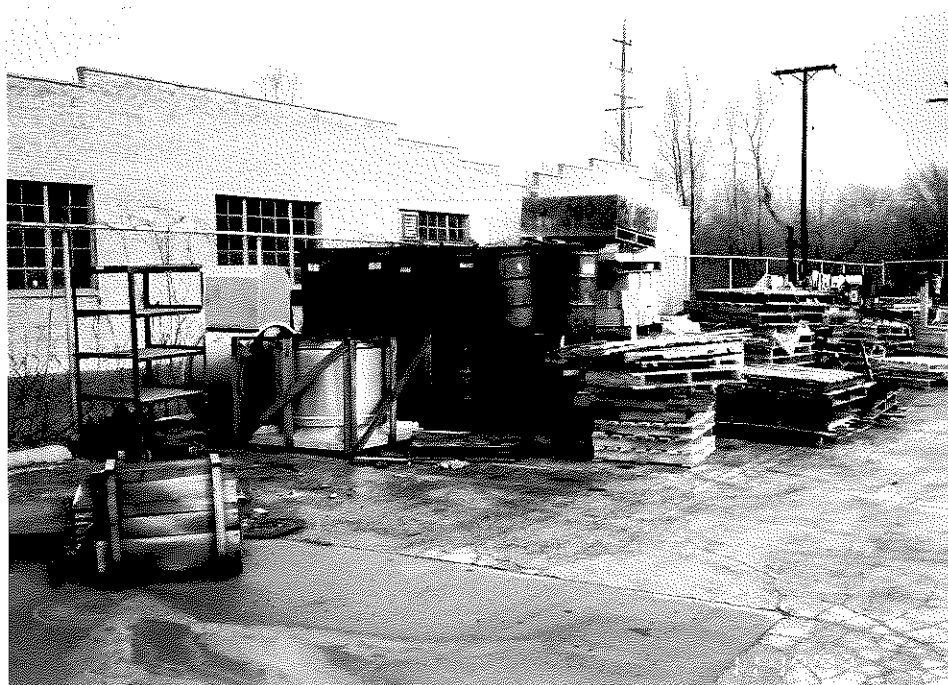
Photograph No. 4
 Orientation: Northeast
 Description: Deteriorating drums of soil cuttings surrounded by wooden pallets and other debris

Location: SWMU 1
 Date: 11/19/93

PRC recommends that hazardous wastes managed in SWMU 1 have secondary containment which would adequately hold spills of liquid waste, although this is not a RCRA requirement. PRC bases this recommendation on its observations and on the numerous compliance inspections which have noted poor housekeeping practices in SWMU 1. Caustic sludge, which is not regulated as a hazardous waste, but may be characteristic for corrosivity, should be managed on site as a hazardous waste.

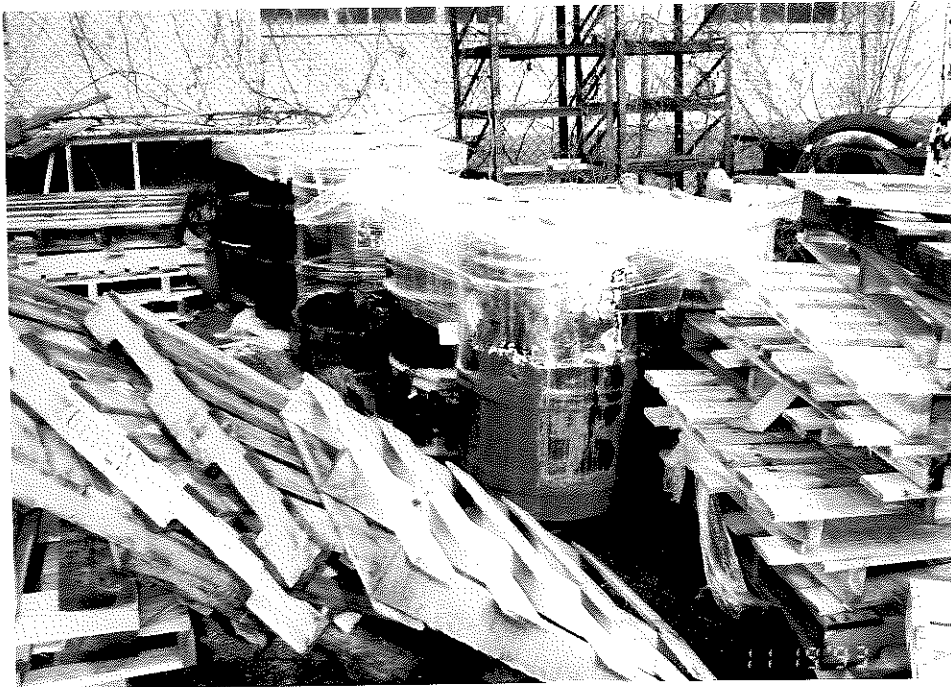
Photograph No. 5

Description: Deteriorating drums of soil cuttings surrounded by wooden pallets

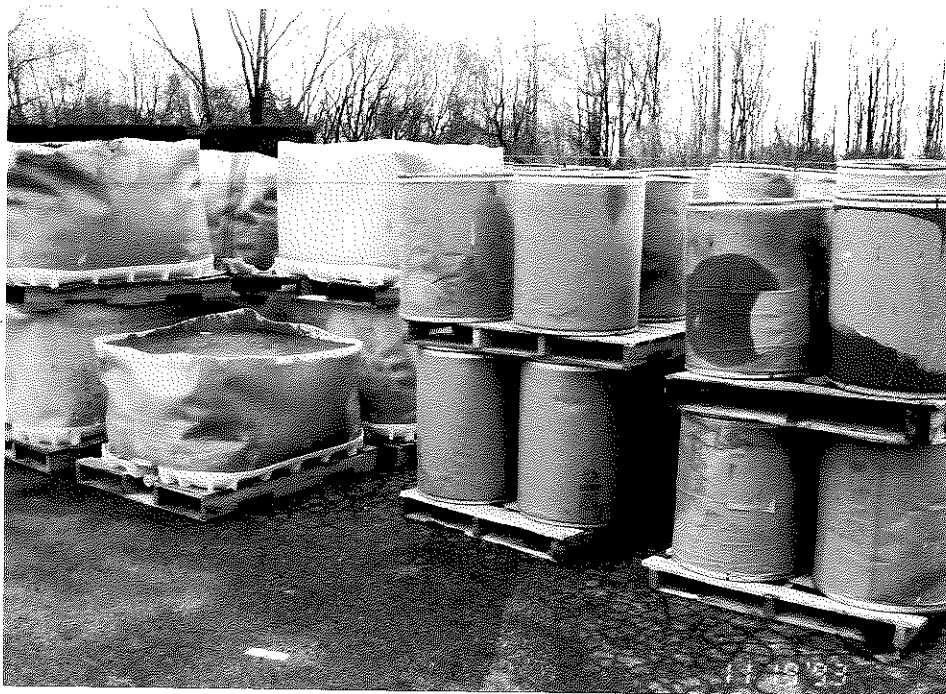
Photograph No. 6

Wooden pallets, old process equipment, and other items were also stored in this area during the VSI. PRC noted that the asphalt was unsealed and heavily cracked throughout. The unit was unbermed and any release could potentially migrate from the facility directly onto off-site soils. The facility representative pointed out a break in the fence where vandals had entered to steal scrap metal. The break has been repaired. A 5-foot by 5-foot section of this unit has been designated for management of hazardous waste. The area is marked by yellow spray paint on the asphalt and is located against the fence on the far east border of the property. The hazardous waste containers were labeled, stored closed, and in good condition. Photograph No. 1 shows the metal filing and scrap containers. Note the storm sewer drain, surrounded by water, in the background. Two monitoring wells are also visible. The dumpster for caustic sludge was covered by a tarp (see Photograph No. 2). The waste oil drums were stored closed and in fair condition (see Photograph No. 3). Containers (55-gallon drums) of soil cuttings were found to be deteriorating and several labels were illegible (see Photographs No. 4 and 5). Used wax containers (plastic and cardboard) were stored open, however, this is probably an acceptable practice because the wax is solidified (see Photograph No. 6).

Description: Plastic and cardboard containers of used wax maintained on pallets

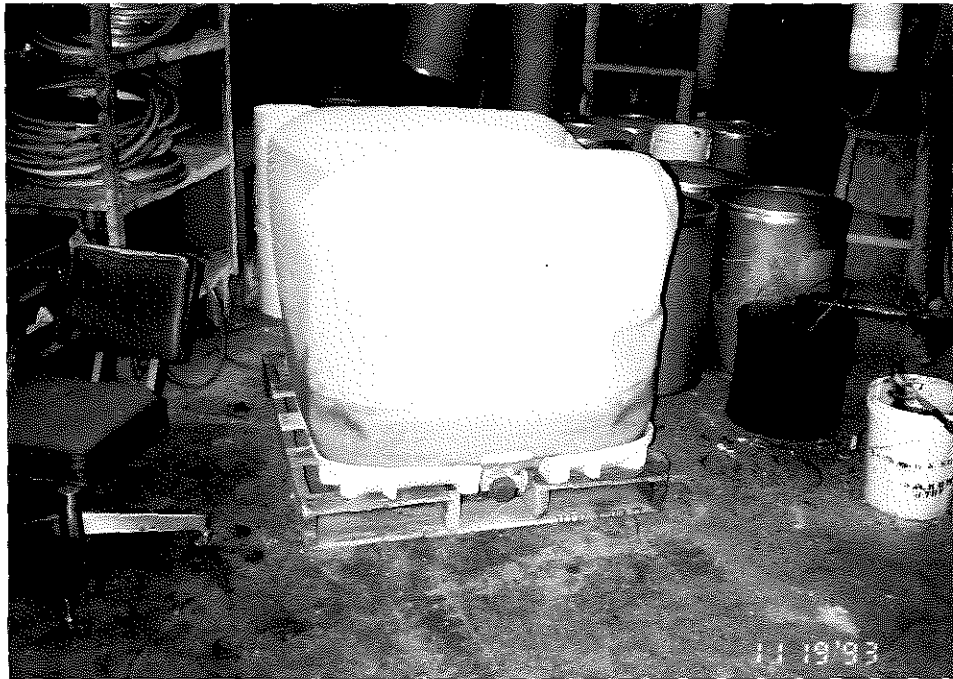
Photograph No. 7

Observations: During the VSI, the unit contained one partially full 5-gallon pail and one partially full 1.5-yd³ container of used wax. PRC noted spilled wax that had hardened on the floor beneath the collection pail (black pail in photograph) (see Photograph No. 7).

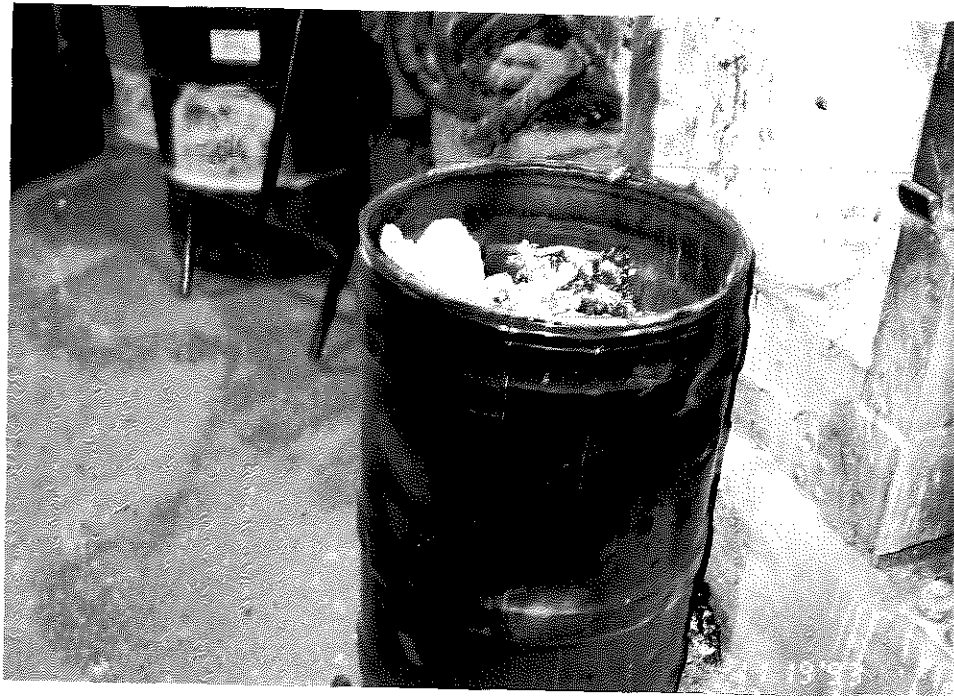
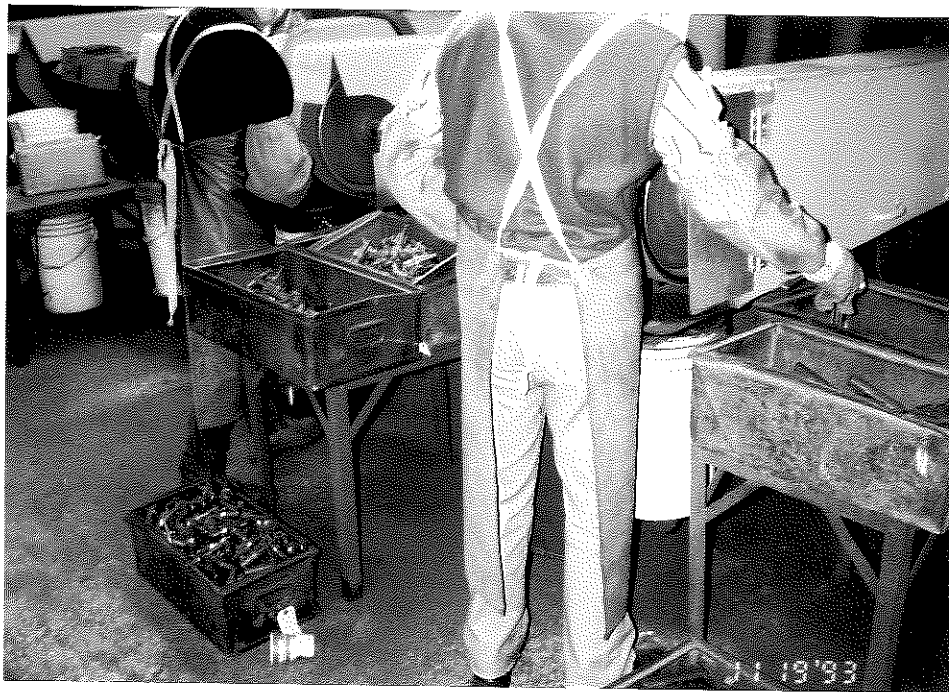
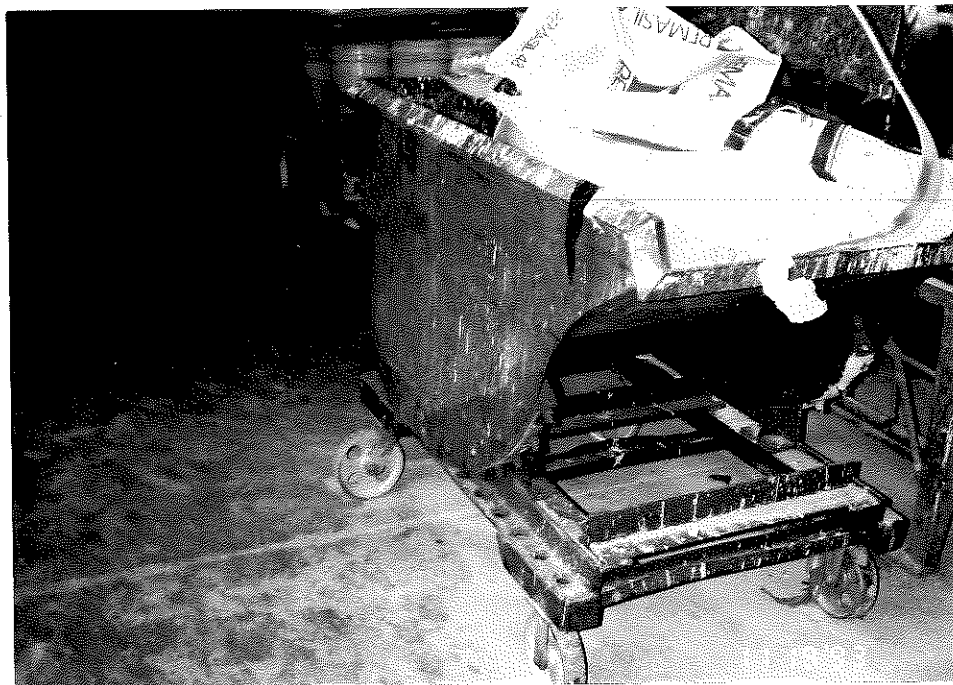
Observations: The unit contained various quantities of nonhazardous wastes during the VSI. PRC noted that the accumulation containers were in good condition (see Photographs No. 8, 9, and 10).

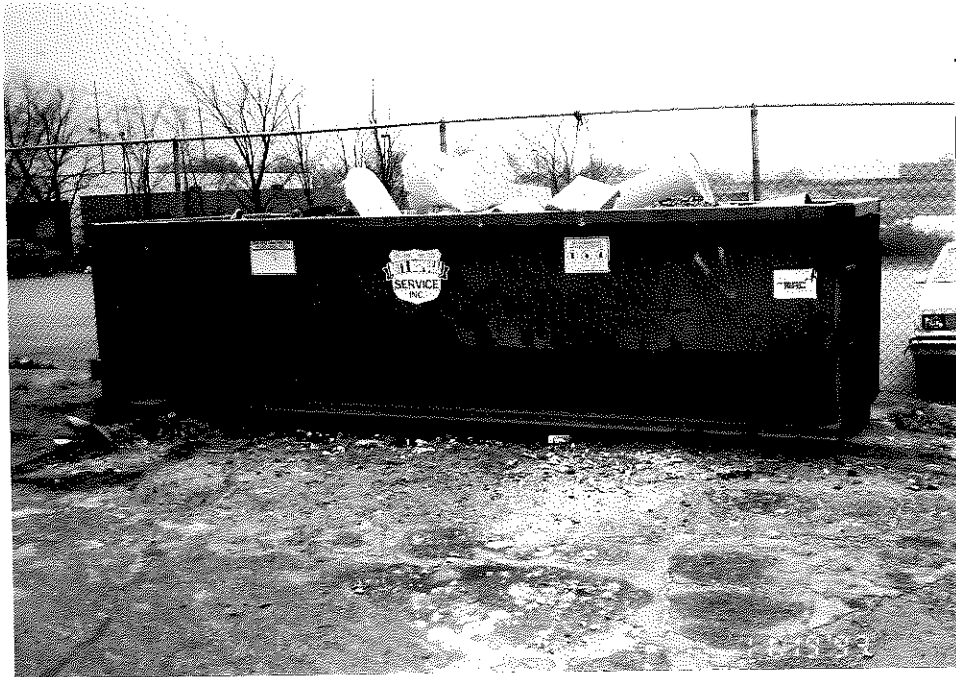
Photograph No. 11
 Orientation: South
 Description: Dumpster containing general refuse and broken molds

Observations: The unit contained general refuse and broken molds during the VSI. PRC noted that debris from broken molds was scattered on the ground around the dumpster. The concrete beneath the dumpster was broken to the extent that in places there appeared to be exposed soil (see Photograph No. 11).

Location: SWMU 4
 Date: 11/19/93

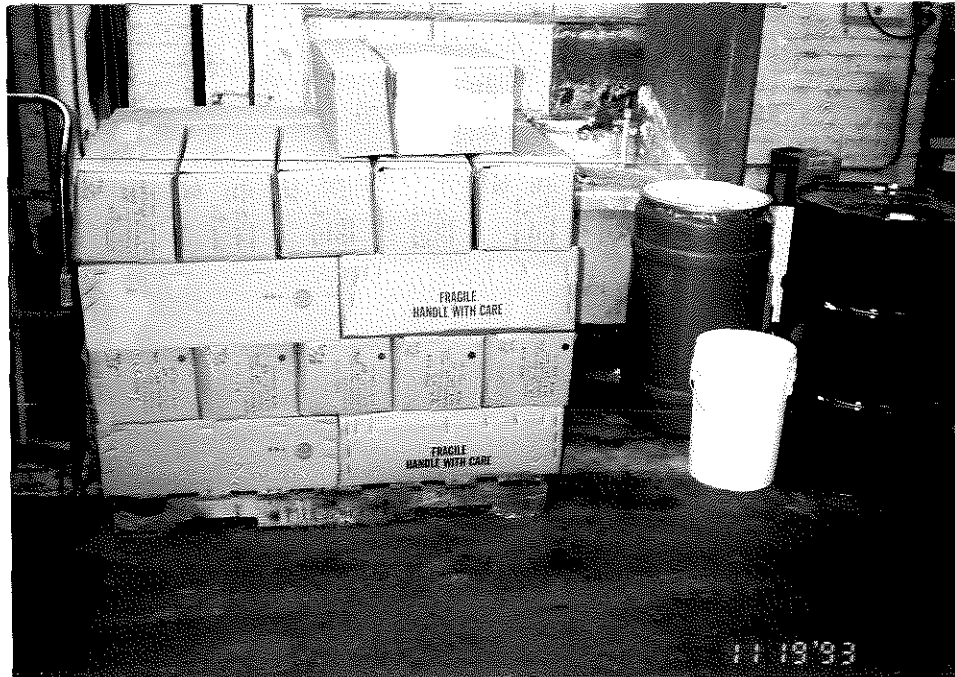
The unit did not contain any waste during the VSI. PRC noted no evidence of release. Photograph No. 14 shows the area of the shipping department where the process tank is located. Spent acid containers are managed in this area.

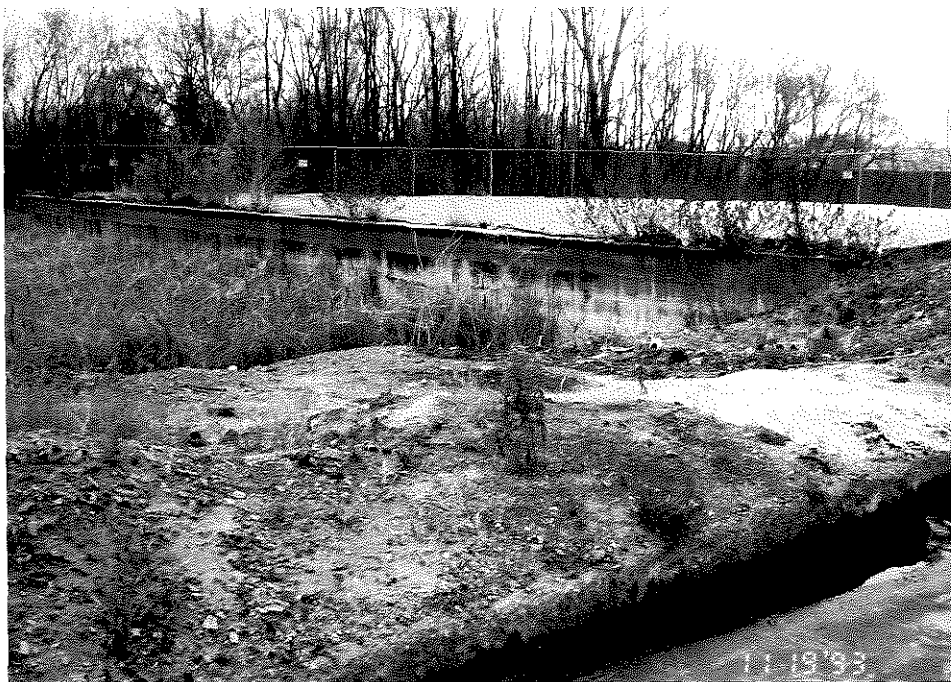
Photograph No. 15

The unit was overgrown with cattails during the VSI, and did not appear to be covered by the tarp. The west end of the unit contained what appeared to be broken molds (ceramic fill) (see Photograph No. 15).

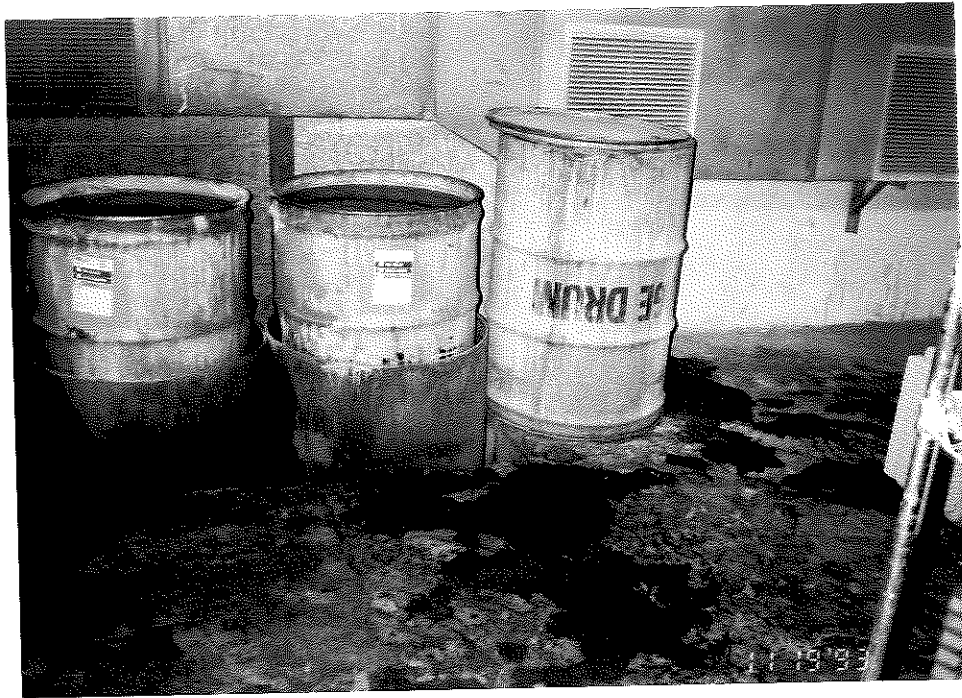
Photograph No. 17

Description: General area where, in the past, hazardous wastes were stored for greater than 90 days. The open containers are now process units. Note the ductwork above the open containers.

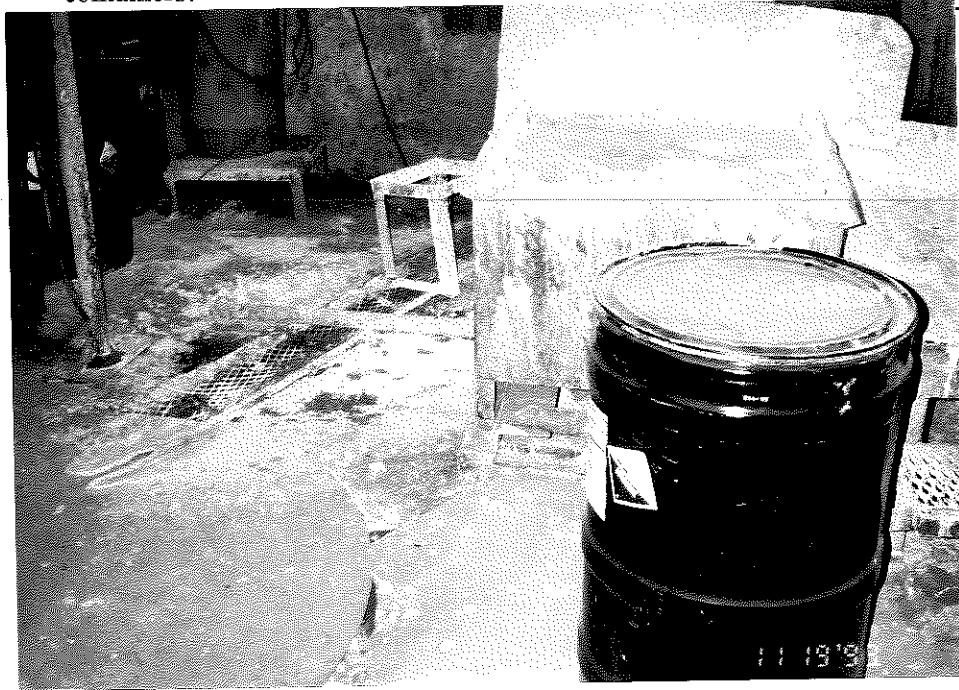
Photograph No. 18

Description: Neutralization sump next to the Kolene machine. Discharge to the sump is through a pipe located behind the Kolene machine and is not visible in the photograph. A container of caustic sludge is visible and is considered in this report to be part of SWMU 3.

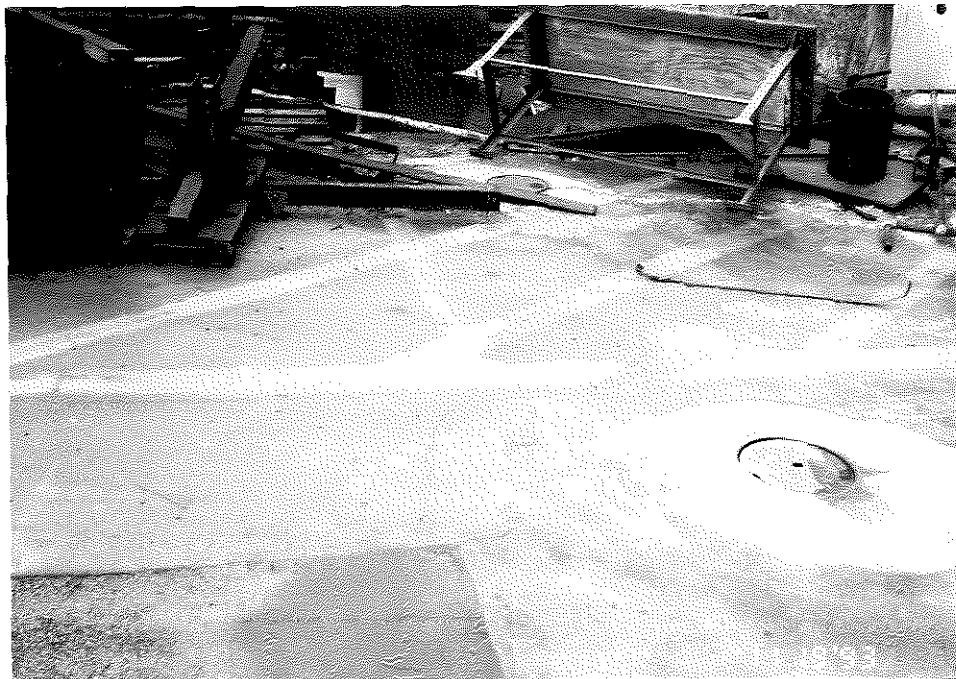
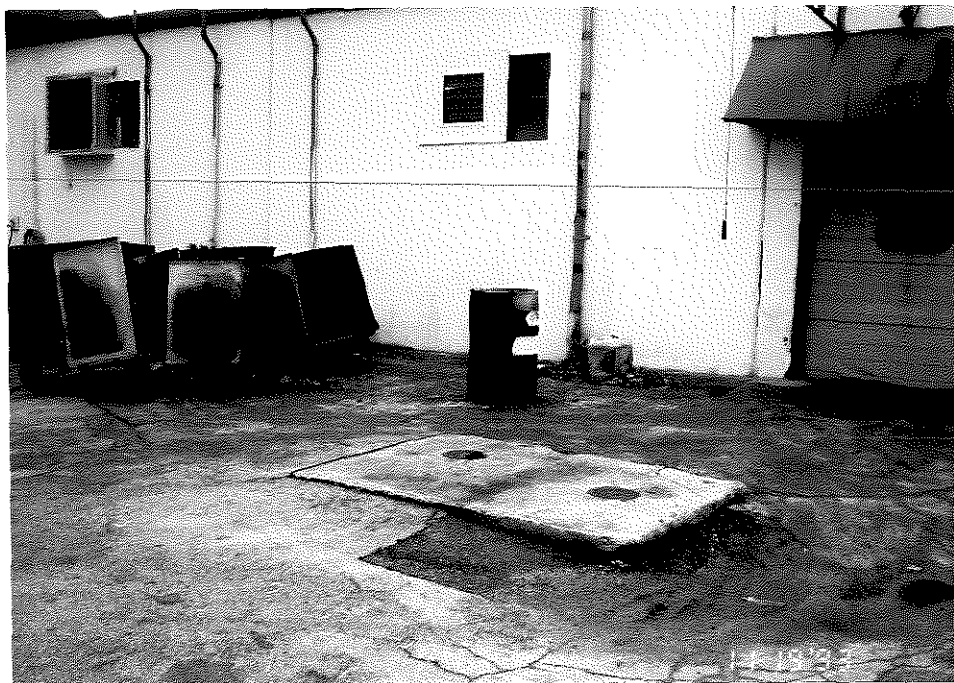
These tanks do not contain materials which are on the CERCLA Hazardous Substance List (40 CFR 302.4). The Fansteel USTs are not regulated as chemical USTs and do not require registration with the State Fire Marshall or IEPA for operation or closure (PRC 1994a). Therefore, the USTs are not considered an AOC in this report. The manhole covers for these USTs are in the Waste Storage Area (SWMU 1) and photographs of them are included in Appendix A as Photographs No. 19 and 20.

Description: Manhole covers for underground storage tanks (UST). Cover in background is for the isopropyl alcohol tank. Cover in foreground is for one of the ethyl silicate tanks.
